# FITTING SCRAPER BOARD +250° 9360

## **GENERAL INFORMATION**

The Hampus 9360 is a scraper board with a tungsten carbide blade. The scraper board is especially made for cleaning belts with high temperature or belts within high temperature environment. The scraper is fitted to the underside of the return run, usually replacing a return roller.

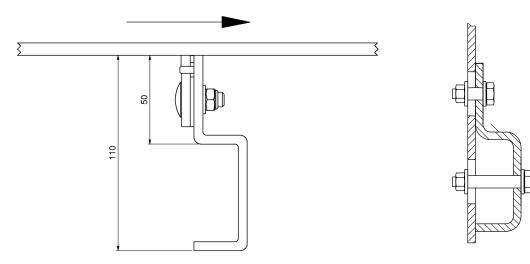
*Fig.1. Scraper board* +250° *installed under the return run of the conveyor.*

1.	The Hampus 9360 is placed on the underside of the return run as shown in fig. 1.
	The scraper is usually fitted to replace a return roller.
2.	Fix the beam to the frame of the conveyor using robust attachments.
3.	Make the attachment so that the beam can be adjusted in the vertical direction.
4.	In order to avoid vibrations in the belt scraper, we recommend that the attachment
	be made using two bolts as in fig. 2.
